ROYAL AIR FORCE BOARD OF INQUIRY

INTO THE LOSS OF:

HERCULES XV179

(IRAQ - 30 JAN 05)

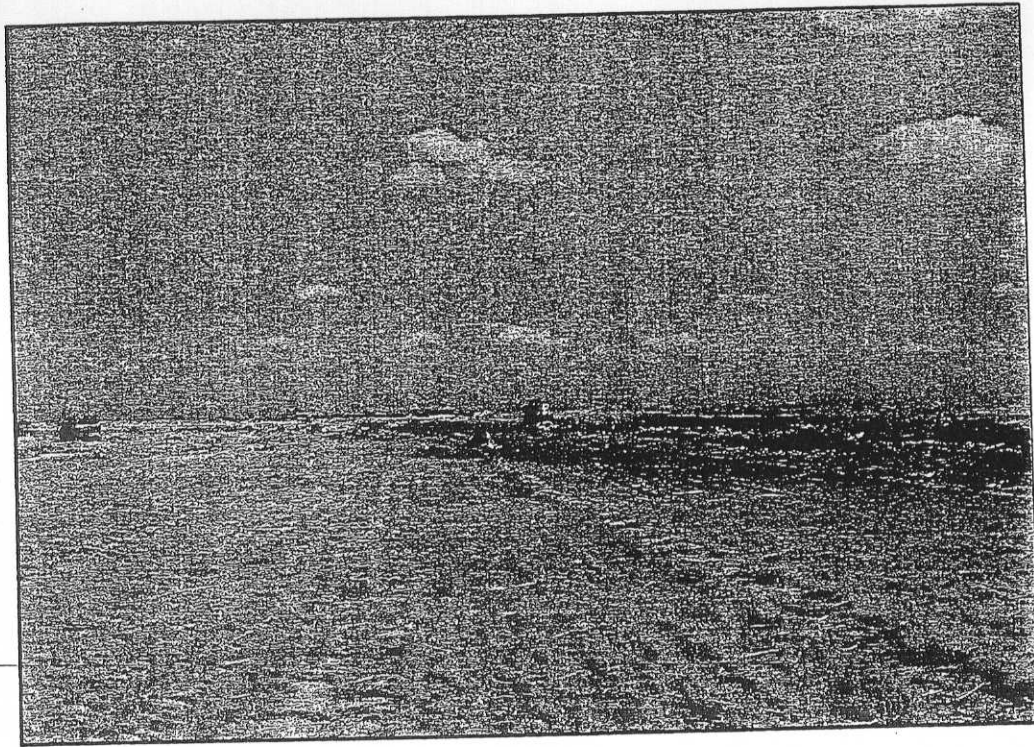
22. Incident Area Topography. The red arrow on Fig 2.1 shows the general area of the incident and the picture at Fig 2.2 gives a view of the topography at the main crash site. The area is completely flat agricultural land, criss-crossed with irrigation canals. There are small clumps of trees dotted across the landscape but none of significant height, nor any electricity pylons or wires within the immediate area. The region is sparsely populated and the local infrastructure is poor.

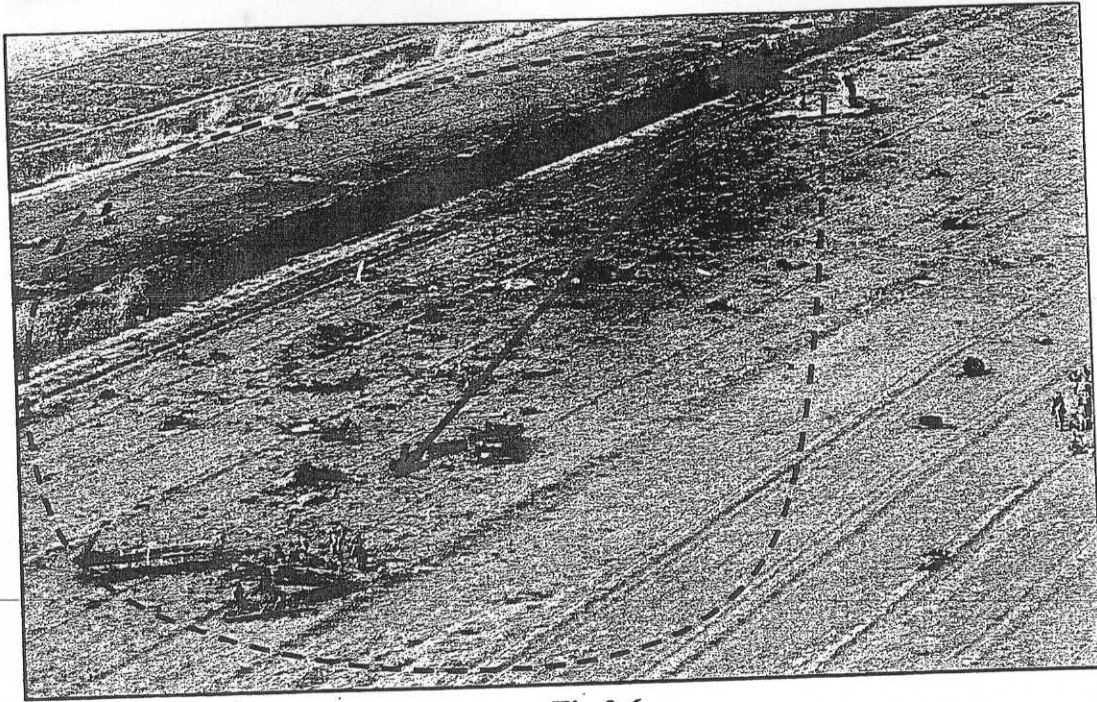
Fig 2.6

stated that the wreckage was consistent with an impact of this nature.

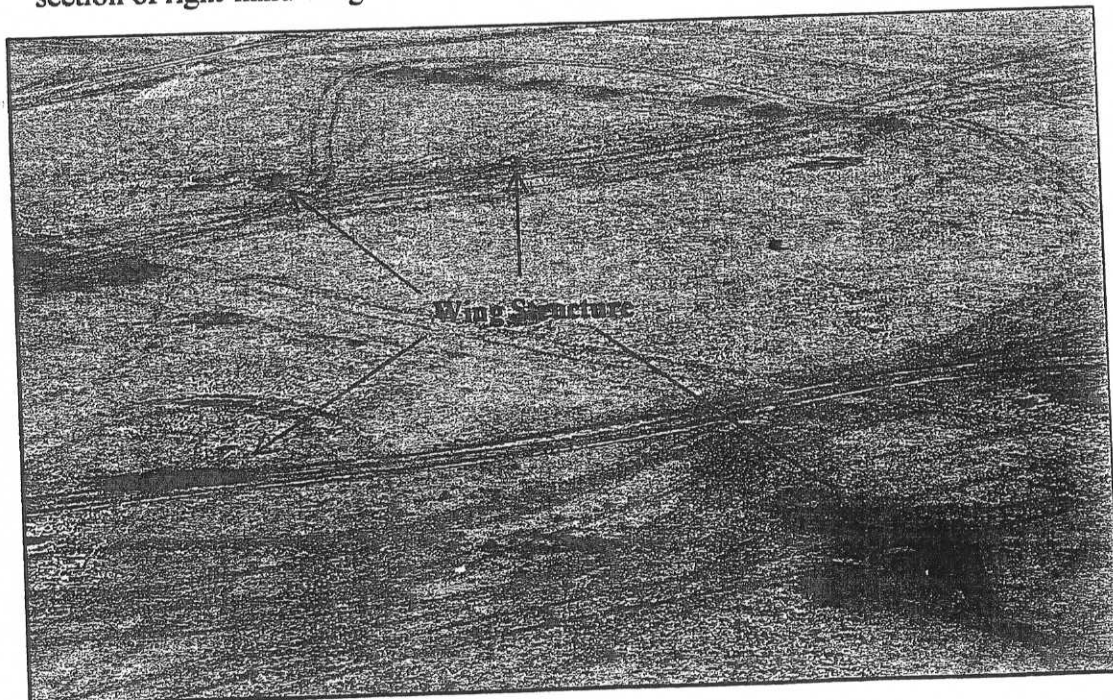
Fig 2.7

b. Remote Site. The wreckage at the remote site was contained within a 100 m radius, as shown at Fig 2.7. The distance between individual wreckage items and the lack of ground witness marks proves that the separated wing section had broken apart before impacting the ground. Suspect bullet holes were found in the structure and there was evidence of both in-flight and ground fires. From the photographs, MA and the AAIB were able to identify the vast majority of the separated section of right-hand wing.

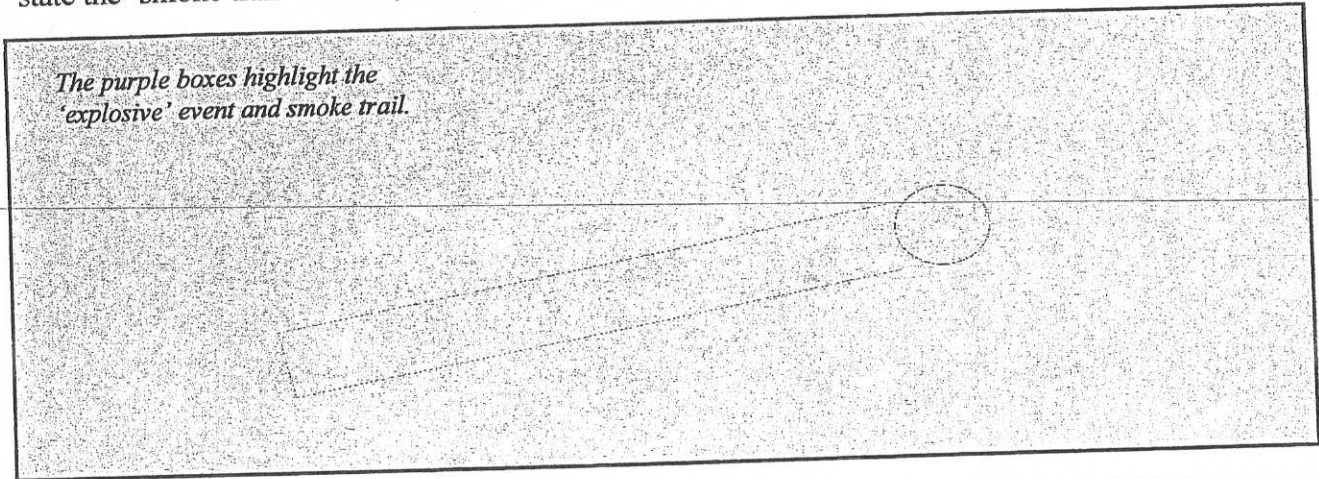
Fig 2.8

The purple boxes highlight the 'explosive' event and smoke trail.

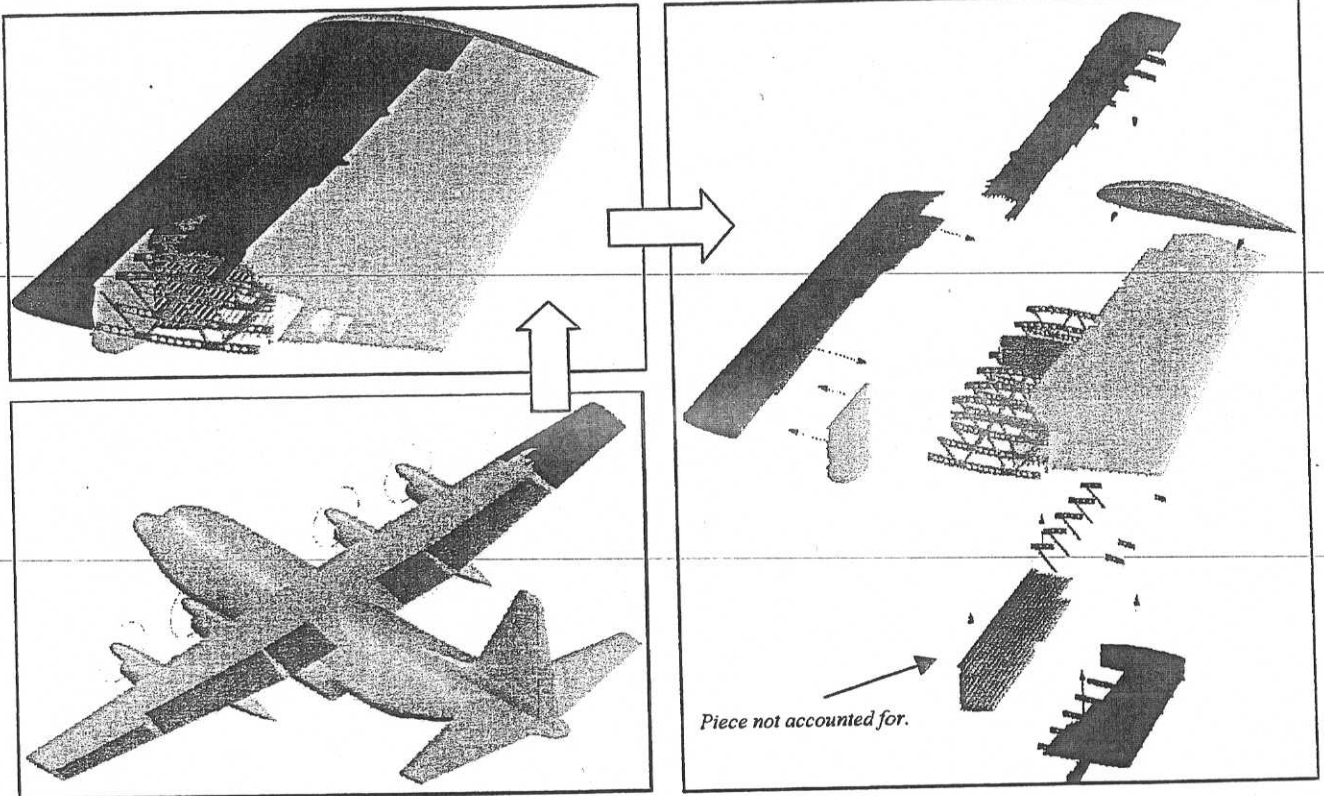
41. The Nature of Wing Separation. The large, relatively intact, but separate sections of outboard wing prove that the wing blew apart due to an internal overpressure. This conclusion is supported by the lack of bending or yielding in the metal structure and the fact that the separated wing section had not detached in one piece, as might be expected from a fatigue failure. Break surfaces were consistent with brittle fractures and fracture lines were random and did not track. The extent of the wing damage is shown in Fig 2.10, which also depicts a computer representation of the individual pieces found at the remote crash site. The over-pressure that

Extent of separated wing section.

Representation of wreckage found at the remote site.

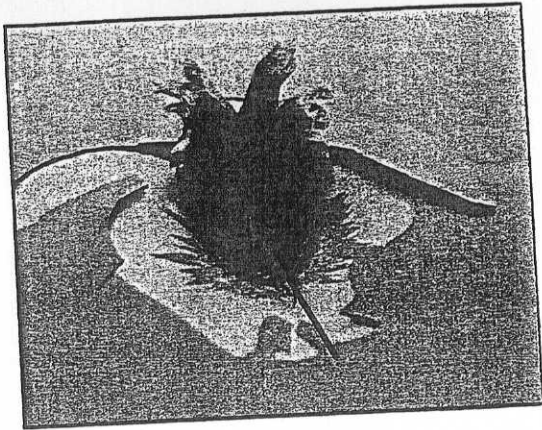
Fig 2.13

d. Small Arms/Light Anti-Aircraft Artillery. The Board found evidence of bullet damage on the right-hand wing at the remote crash site. Analysis by DSTL has confirmed that this damage was caused by mm rounds. The calibre of munition was ascertained from the dimensions of the bullet holes and the assertion that they were is based on the fact that all known mm ammunition in the Iraqi theatre is either or (with). The similarity between one of the bullet entry holes made by a mm round during the Board's live-fire trial, shown at Fig 2.13, and one of the entry holes found on XV179's wing, shown at Fig 2.14, is clear. It was possible to prove

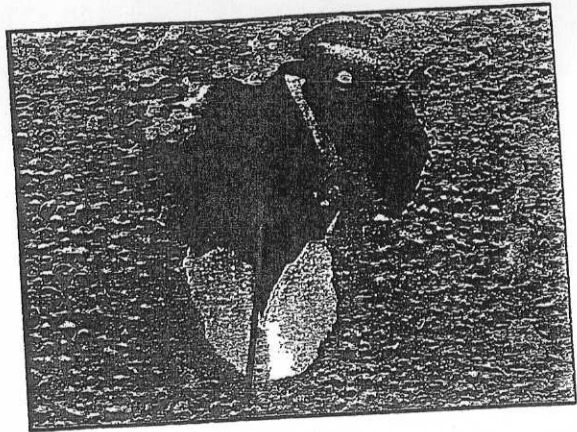
Fig 2.14

that XV179's wing had been shot whilst still intact (ie the wreckage was not shot on the ground) by using photographs from the remote crash site to reconstruct the wing physically, as a model, and digitally through a Computer Aided Design (CAD) programme, which proved the alignment of bullet holes. One of the CAD drawings from the AAIB's Final Report showing the bullet hole alignment can be see at Fig 2.15. Additionally, ballistic and fracture damage was marked onto an intact Hercules wing, which further substantiated this conclusion.

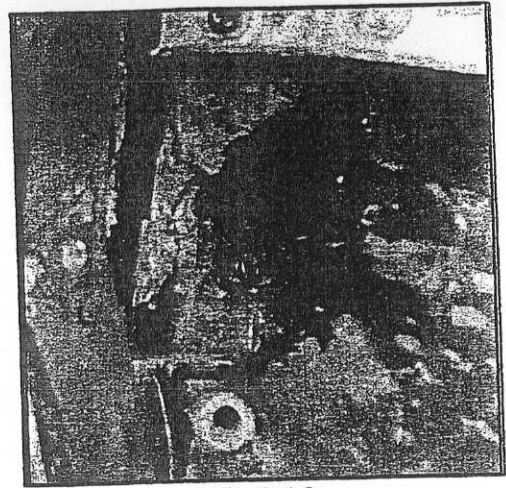
Fig 2.16

49. Analysis of [redacted] mm [redacted] Rounds Hitting the Number 4 Fuel Tank. As previously discussed, the impact of any round into aluminium ac structure could provide an ignition source, especially [redacted] or [redacted] rounds. Indeed, when the Board fired [redacted] mm [redacted] rounds from a [redacted] into a section of Hercules tailplane at a range of 600m, a fire was observed on the 'dry' aluminium structure. The sooting from this fire can be clearly seen in Fig 2.16. In the case of XV179, such an event may have caused an

instantaneous explosion of the fuel/air mix in the ullage, or a fuel fire (either internal or external) that led to an explosion once the conditions were correct. Furthermore, the effect of a [redacted] mm bullet impacting the fuel tank could have been increased by the affect of hydrodynamic ram. (In this instance, hydrodynamic ram refers to the overpressure produced by the motion of a bullet, and any accompanying fragments, inside a body of fuel within a fuel tank) This force could potentially result in a fuel tank rupturing from the penetration of one round. Such an affect can be seen in Fig 2.17, which shows the result of a water-filled oil drum having been hit by a single [redacted] mm [redacted] round.

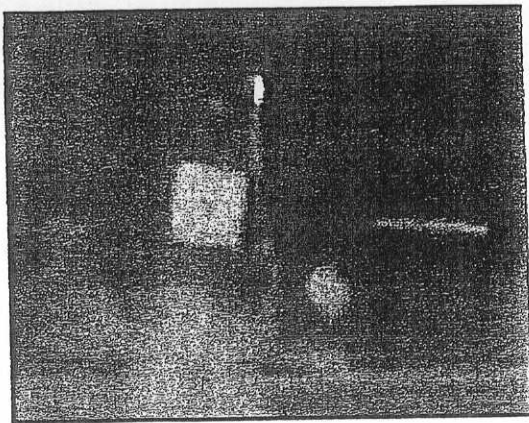
Fig 2.18

A further effect of hydrodynamic ram would be to agitate the fuel, thus increasing the chance of creating an explosive mix. During the firing trial, the Board noted the similarity between the appearance and trajectory of [redacted] mm tracer rounds and the "orange fireballs" with "light grey smoke trails" described by some of the witnesses. Examples of [redacted] and [redacted] mm tracer rounds at a range of approximately 1000 m are shown on the left and right, respectively, of Figs 2.18 and 2.19. The Board has concluded that the

outboard section of the right-hand wing was definitely hit by two $\frac{f}{mm}$ rounds and the $\frac{f}{mm}$ associated with these rounds could be the observed 'fireballs'. The path of one of the rounds carried it through the right-hand aileron dry-bay into the number 4 fuel tank ullage, making it an ideal trajectory to cause the loss of fuel, an external fuel fire and/or an instantaneous fuel/air explosion. Whilst the AAIB assert that an RPG, or similar weapon, struck the wing, it has not been possible to corroborate this hypothesis, by any of the scientific methods used to verify such an event. Indeed, photographed structure in very close proximity to this suspect area is undamaged by explosion or fire. However, the penetration of $\frac{f}{mm}$ rounds and the possible catastrophic consequences of such an impact can be proved; furthermore, the AAIB confirms that multiple hits from such a weapon system could have caused the observed damage at the separation point. On balance, therefore, the Board concluded that $\frac{f}{mm}$ rounds are highly likely to have initiated the catastrophic wing over-pressure.
