ROYAL AIR FORCE BOARD OF INQUIRY

INTO THE LOSS OF:

HERCULES XV179

(IRAQ - 30 JAN 05)

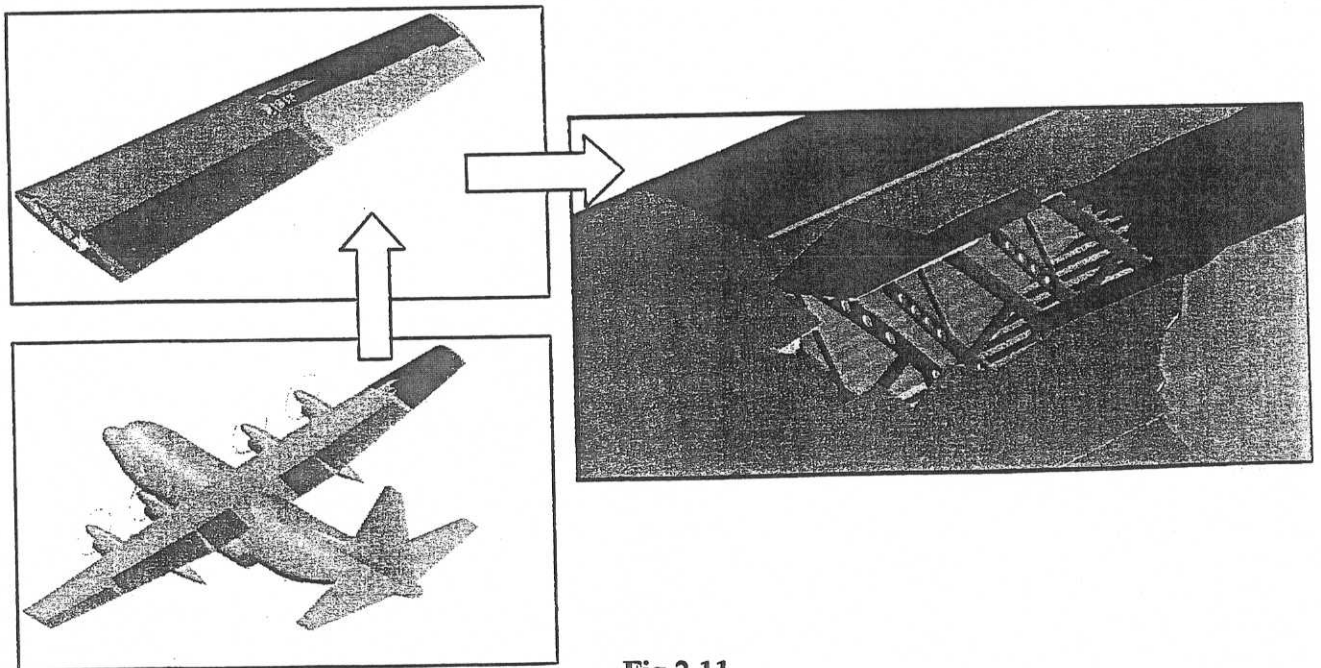
Fig 2.11

observed ballistic damage could have reduced the tank quantity thereby increasing the ullage volume, or a fire, caused by the ballistic damage, could have increased the ullage temperature. There is some evidence of airborne fire damage to the separated wing sections and the remaining section of right-hand wing at the main crash site. However, the AAIB conclude that there was no evidence consistent with a sustained airborne fire in the separated wing section and that the fire damage visible in this part of the wreckage occurred after separation, either as the sections fell or as a result of subsequent ground fire. There is evidence of sustained airborne fire on the remaining section of wing at the separation point, which is also likely to have occurred after separation, although evidence for this is less conclusive. This fire caused significant damage to the trailing edge of the wing, in the vicinity of OWS 300, and the observed damage is indicative of significant and sustained sideslip. After detailed inspection of the separation at OWS 317, the AAIB Senior Investigator concluded that there was some evidence of a large penetration consistent with projectile impact. Two localised areas of ragged failure contrasted strongly with the more regular pattern of failure observed elsewhere on the separated wing section. The location of this suspect damage is shown in Fig 2.11. If such a penetration existed, it would allow rapid draining of the fuel tank, provide a possible source for sustained fire and locally reduce the wing's structural strength, which would account for this area becoming the separation point. The source of ignition for the explosive over pressure is discussed later in this report; however, the Board has concluded that the explosive separation of XV179's wing was caused by the ignition of the fuel/air mix in the number 4 fuel tank ullage. Furthermore, the Board concluded that the lack of a suppression system within the fuel tank, such as foam or inert gas, was a contributory factor. The Board also concluded that the violence associated with the separation and the resulting fire, caused significant damage to the remaining section of wing. Consequently, the aerodynamic effect on the ac would have been more significant than the loss of the outer wing section in isolation.

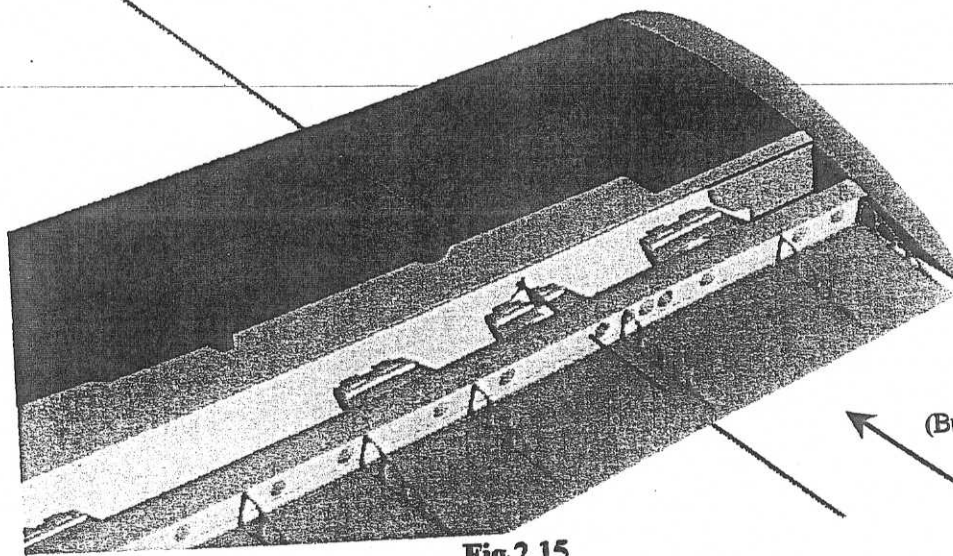
Fig 2.15

that XV179's wing had been shot whilst still intact (ie the wreckage was not shot on the ground) by using photographs from the remote crash site to reconstruct the wing physically, as a model, and digitally through a Computer Aided Design (CAD) programme, which proved the alignment of bullet holes. One of the CAD drawings from the AAIB's Final Report showing the bullet hole alignment can be see at Fig 2.15. Additionally, ballistic and fracture damage was marked onto an intact Hercules wing, which further substantiated this conclusion.
